Fire Risk Assessment

1`University of Sheffield - Stephenson South Wing

14 Sep 2020

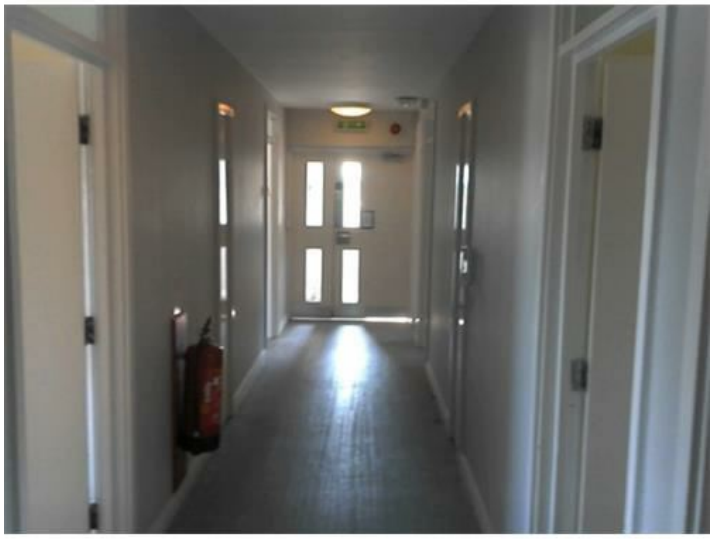
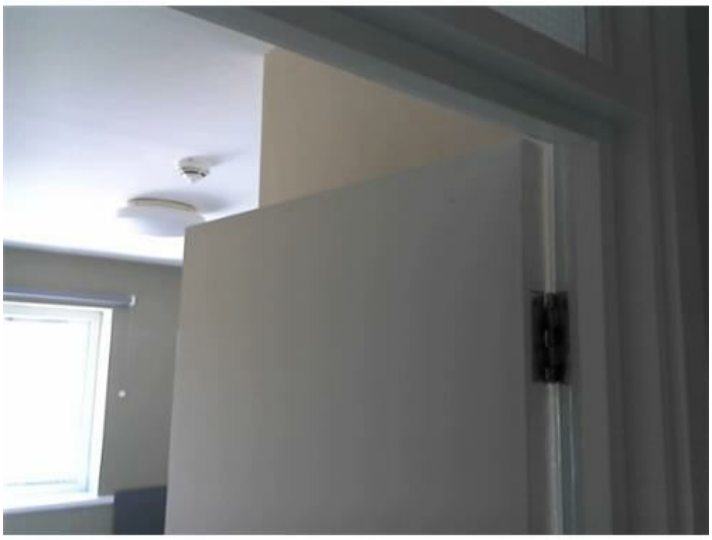
Ref	Sub Section	Question	Non-conformity	Recommendation	Location	Who is responsible	By When
11725247	NR-49-198-1	Do the fire resisting door sets meet the appropriate standard?	All bedroom door are marked up as being fire doors,but do not have closures fitted, or intumescent strips and cold smoke seals. So are all left open, which would allow any fire to spread.	Confirm the fire strategy for these corridors and if required fit door closures, intumescent strips and cold smoke seals.	All bedroom doors all levels	Statutory requirement for the Client	14/12/2020

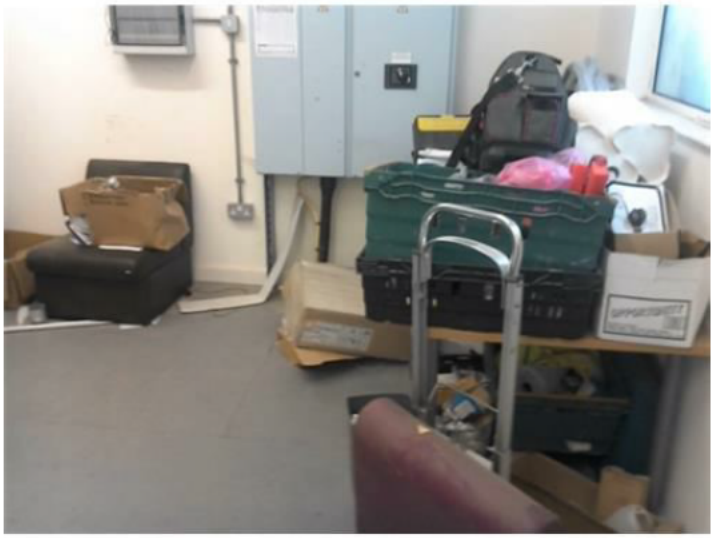
2020916122625.jpg

Ref	Sub Section	Question	Non-conformity	Recommendation	Location	Who is responsible	By When
11726681	A	Are house keeping arrangements satisfactory?	Inappropriate use of rooms/space.	The room/space should be utilised for the purpose for which it was designed.	[redacted]	Statutory requirement for the Client	16/10/2020

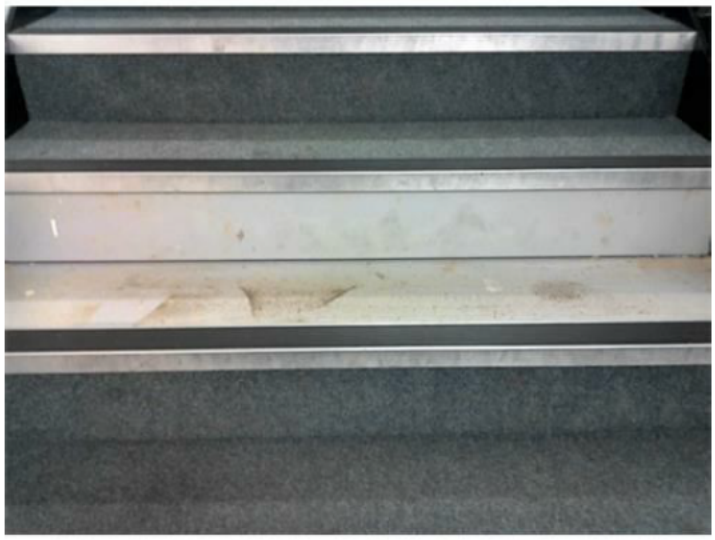
2020916124839.jpg

Ref	Sub Section	Question	Non-conformity	Recommendation	Location	Who is responsible	By When
11726668	B	Are house keeping arrangements satisfactory?	The floor coverings present a trip hazard.	The existing floor covering requires repair or replacement.	[redacted]	Statutory requirement for the Client	15/12/2020

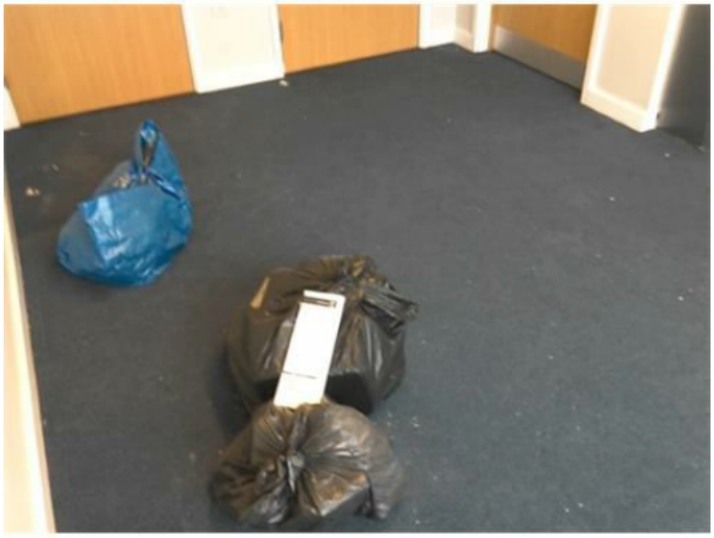
2020916111452.jpg

Ref	Sub Section	Question	Non-conformity	Recommendation	Location	Who is responsible	By When
11726591	M	Are house keeping arrangements satisfactory?	Poor housekeeping has resulted in an accumulation of rubbish, waste paper or other materials that could catch fire or be set alight.	Ensure an adequate housekeeping policy is implemented, consolidated with periodic management inspections.	B6 lift lobby	Statutory requirement for the Client	16/10/2020

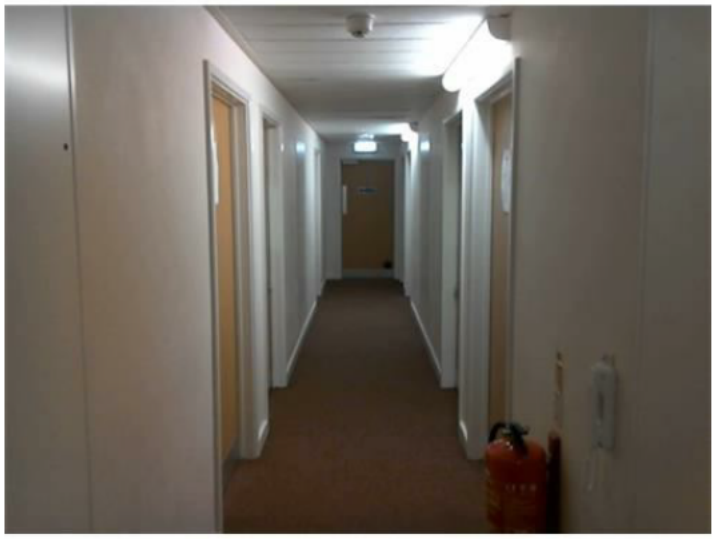
Ref	Sub Section	Question	Non-conformity	Recommendation	Location	Who is responsible	By When
11726632	K	Are there adequate and suitable fire safety signs and notices displayed in the appropriate places throughout the premises?	Insufficient directional escape route signs are provided.	To ensure a safe evacuation, directional escape route signs should be provided at the locations shown on the plan in compliance with BS 5499-4. These signs should display in pictorial format the man running through a fire door with an arrow pointing in the direction of travel and should also have the words 'Exit'. This should also indicate every change of direction or level.	A4; B4;A3;B3 C5; D3 flat entrance door E5, E4 G5 corridor	Statutory requirement for the Client	15/12/2020

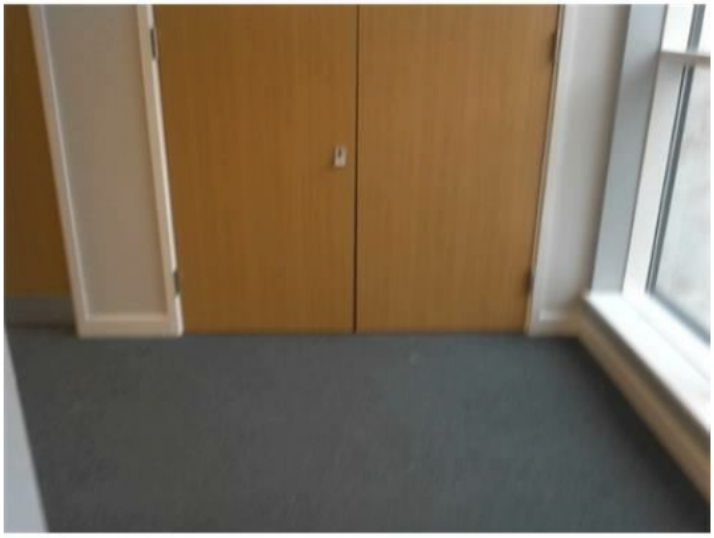
2020916115738.jpg

Ref	Sub Section	Question	Non-conformity	Recommendation	Location	Who is responsible	By When
11726611	X	Do the fire resisting door sets meet the appropriate standard?	The fire doors have a large gap between the doors and the frame which may prevent the intumescent seals being effective.	The doors should be adjusted to ensure that there is no more than a 3mm gap between the hinge edge, leading edge and the top of the door frame.	Level 4, 5, 6 service riser cupboard	Statutory requirement for the Client	15/12/2020
